HEI Systems

Report of Findings

Assessment for Fungi at a Municipal Building
6130 Sunset Drive
South Miami, Florida 33143
File Number: 11-11-0803-M

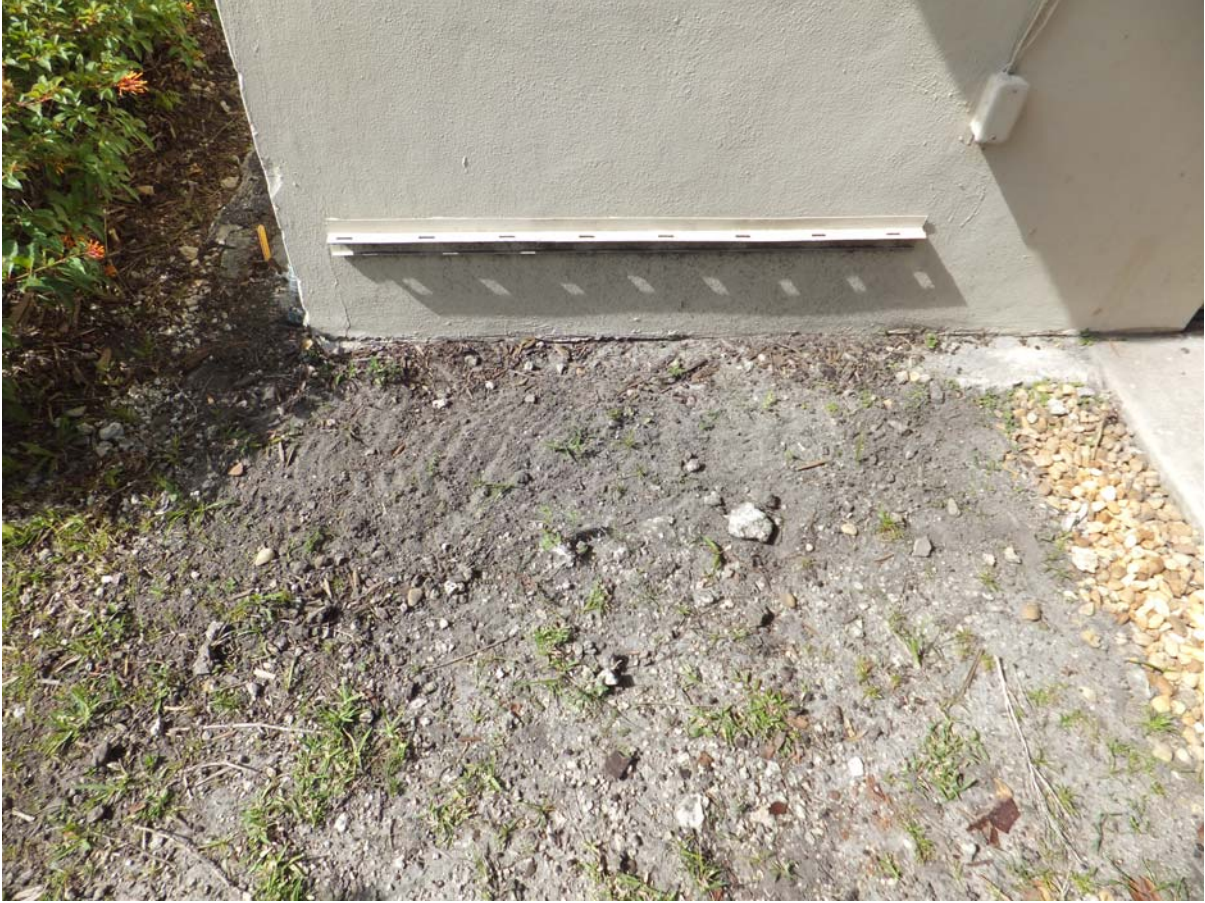
- There is a visible exterior grading issue that should be further assessed by a licensed Professional Engineer. It appears that this grading issue facilitates the water intrusion into the building and should be corrected prior to interior restoration.

Location	WD	FG	EM	Description	Photo #
Exterior				Grading and landscaping issues allow for water intrusion.	2

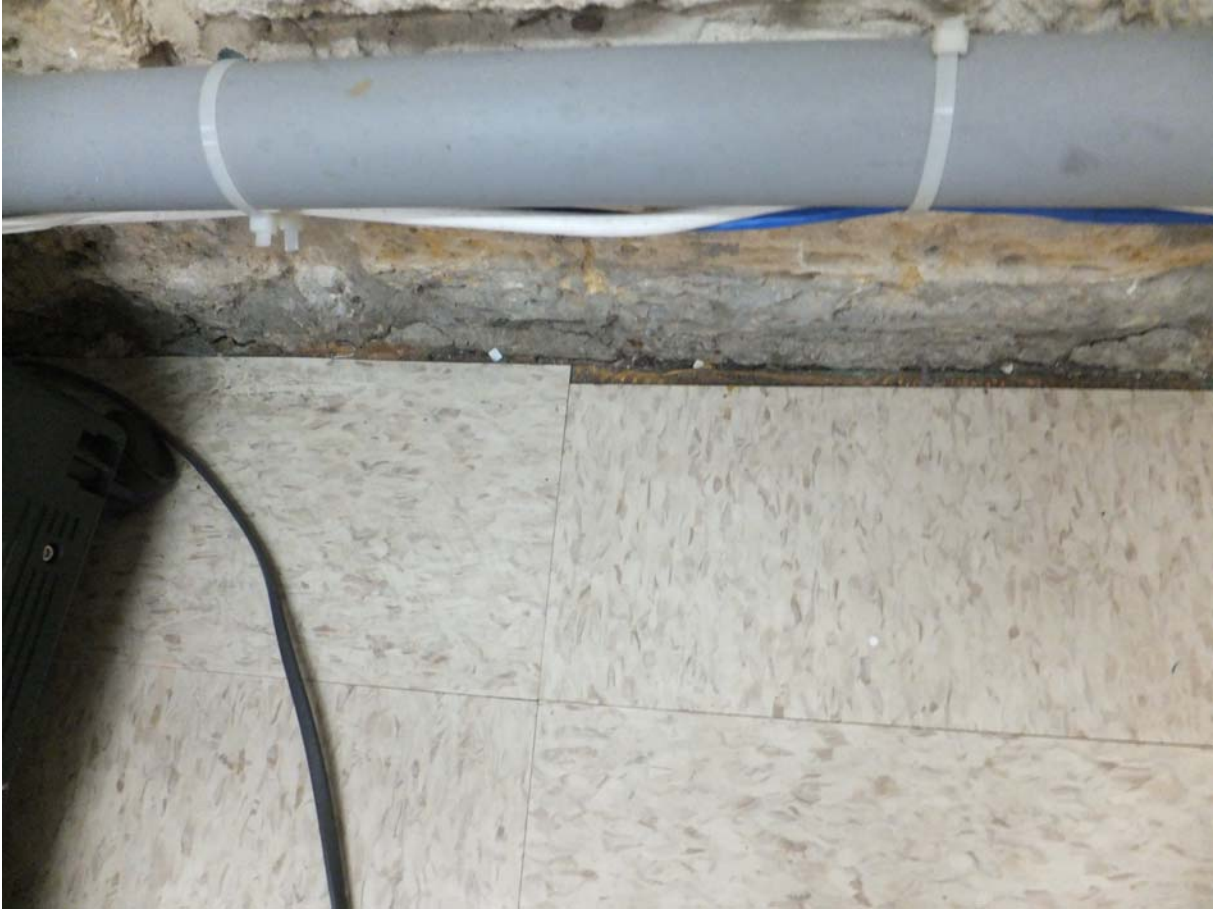
- There is visible water damage and water stains along the wall bottoms in the Central Services Building. There is continued elevated moisture beneath the tile floor covering in the front fingerprint area of this building. There are openings at the edge of the tile floor covering and the adjoining wall that allows water intrusion beneath the tile floor covering. The tile floor covering should be removed under containment and disposed of. The slab should be abrasively cleaned to remove any remaining mastic and then re-sealed prior to the installation of any new floor covering.

Location	WD	FG	EM	Description	Photo #
Front Fingerprint Area	√		√	Separation at wall edge allows water to intrude beneath floor tile and remain captured there.	3

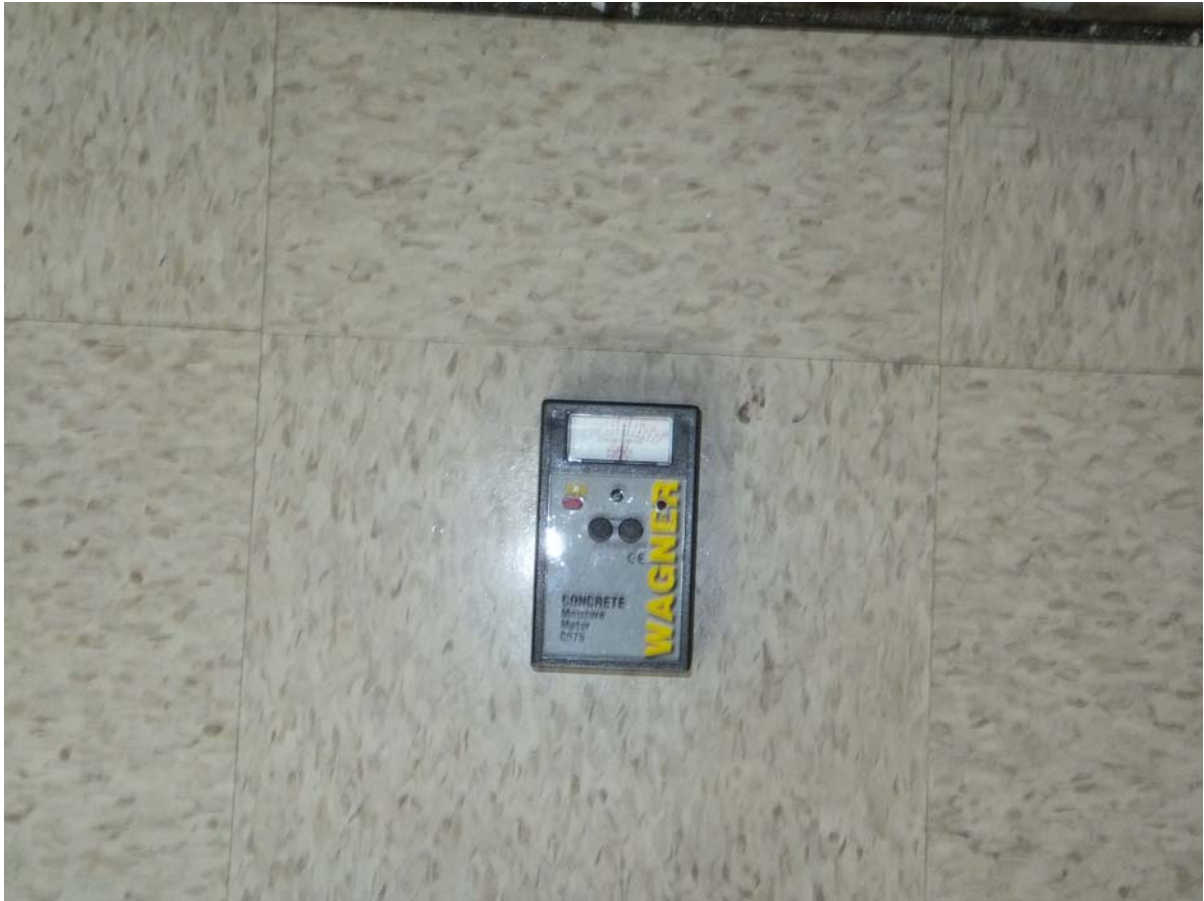
Location	WD	FG	EM	Description	Photo #
Front Fingerprint Area	√		√	Elevated moisture beneath floor tile when measured with a meter.	4

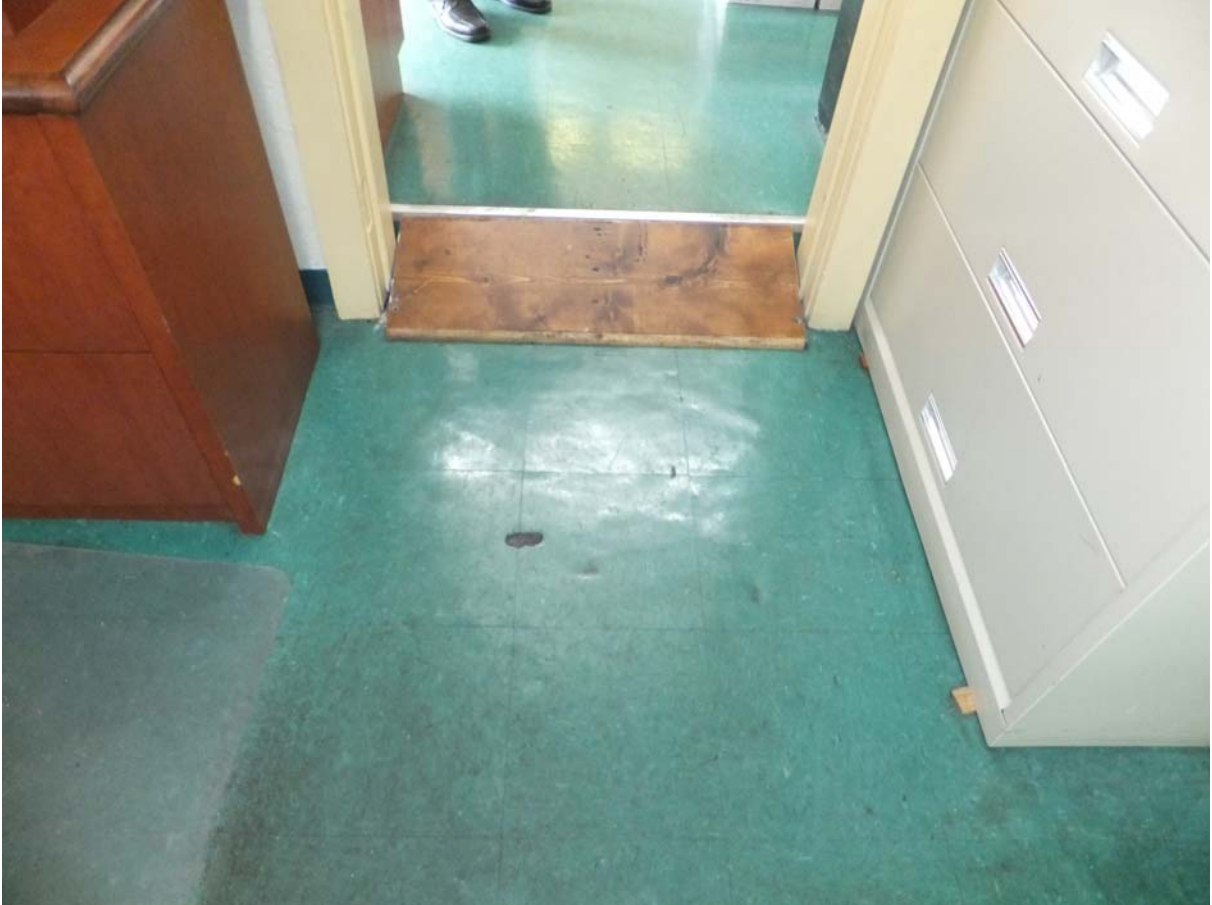
- There is elevated moisture beneath the green tile floor covering in the Middle Room with the copy equipment. The elevated moisture ceases and is not present beneath the floor covering in the back office that is elevated by a step up. There is a distinct possibility that the green tile and mastic used beneath it contain asbestos. As such, this tile should be removed under the proper containment under negative air pressure, with appropriate HEPA filtration in place within the containment and disposed of in a legal manner pursuant to the statutes regulating asbestos. The slab should be abrasively cleaned to remove any remaining mastic and then re-sealed prior to the installation of any new floor covering.

Location	WD	FG	EM	Description	Photo #
Middle Room	√		√	Elevated moisture in Middle Copy area does not extend into back room that is elevated.	5

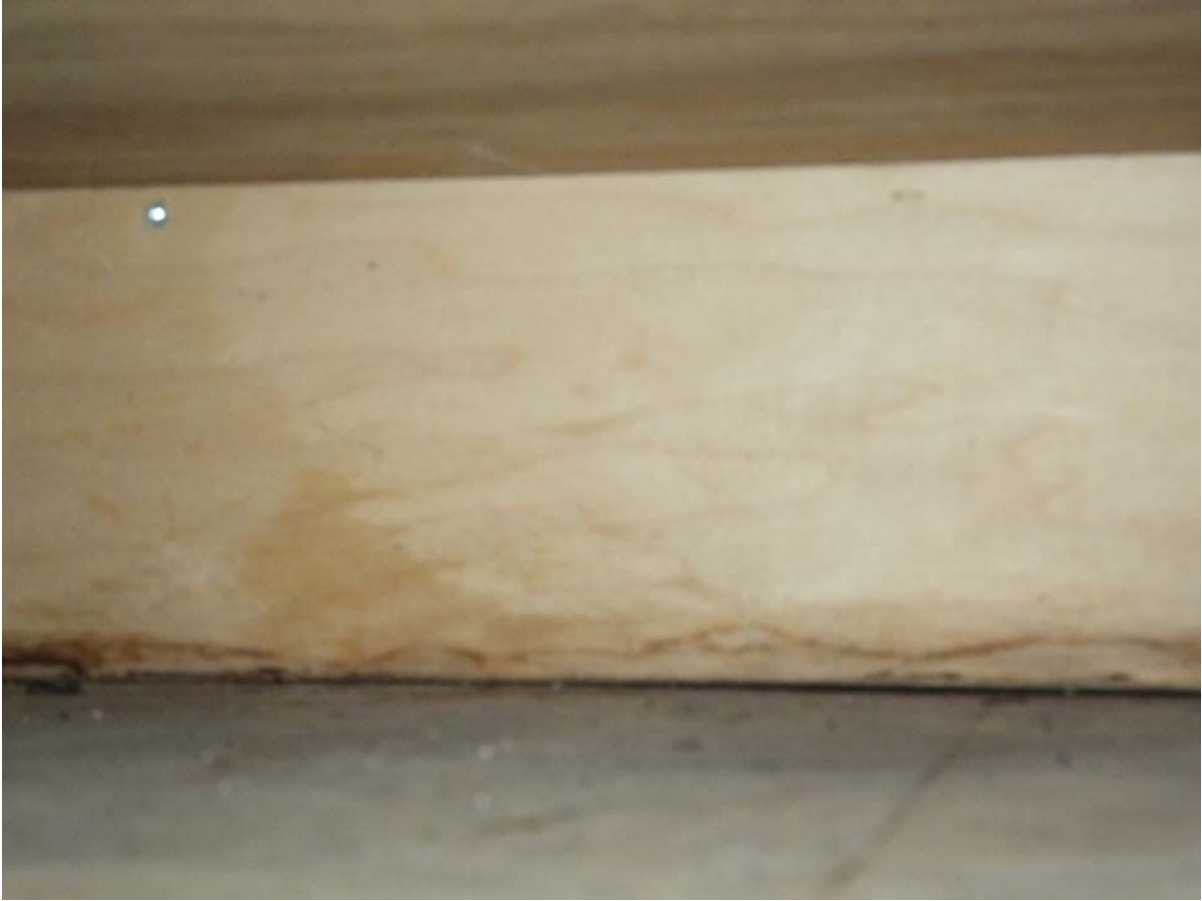
Location	WD	FG	EM	Description	Photo #
Front Fingerprint Area	√			Visible water damage and water staining to cabinet bottoms.	6

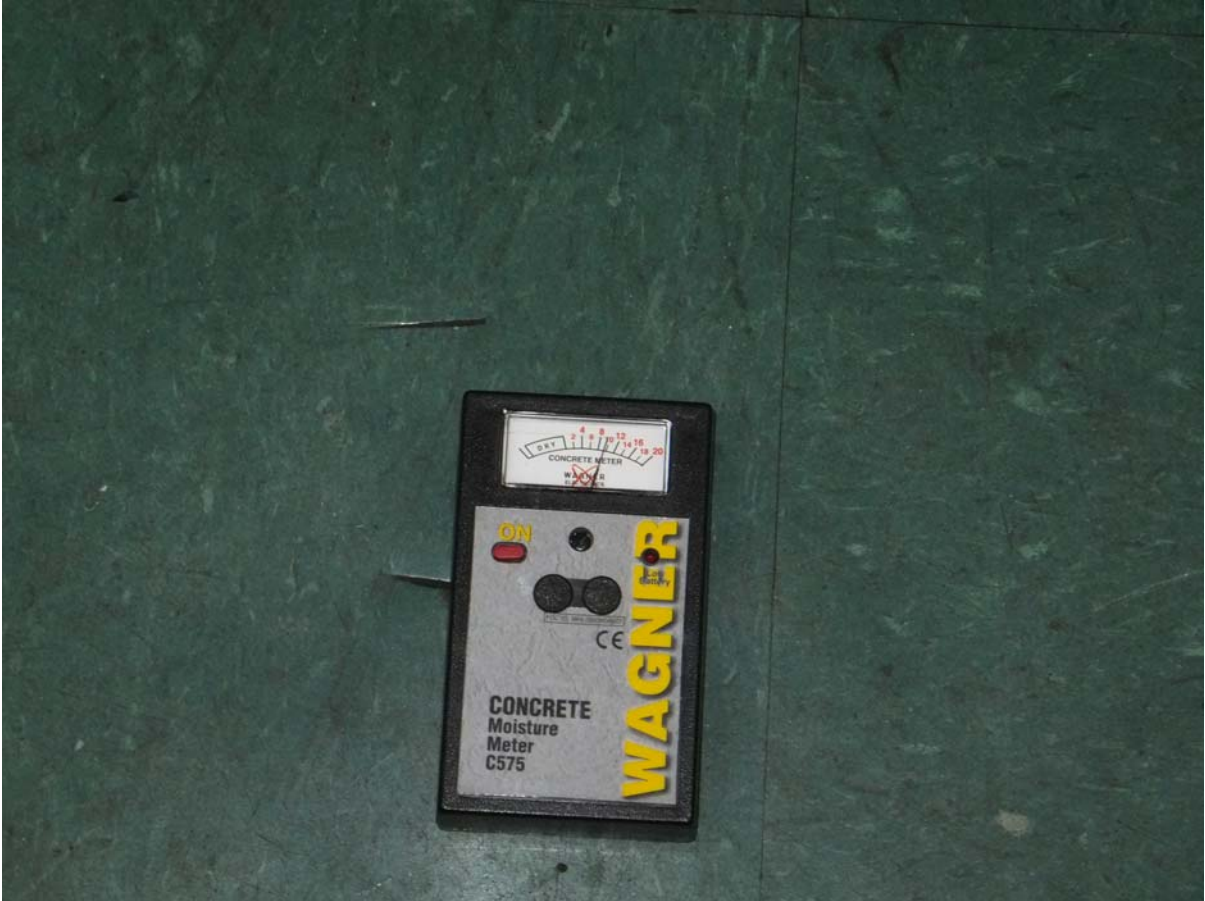
Location	WD	FG	EM	Description	Photo #
Middle Copy Room	√		√	Elevated moisture beneath tile floor covering.	7

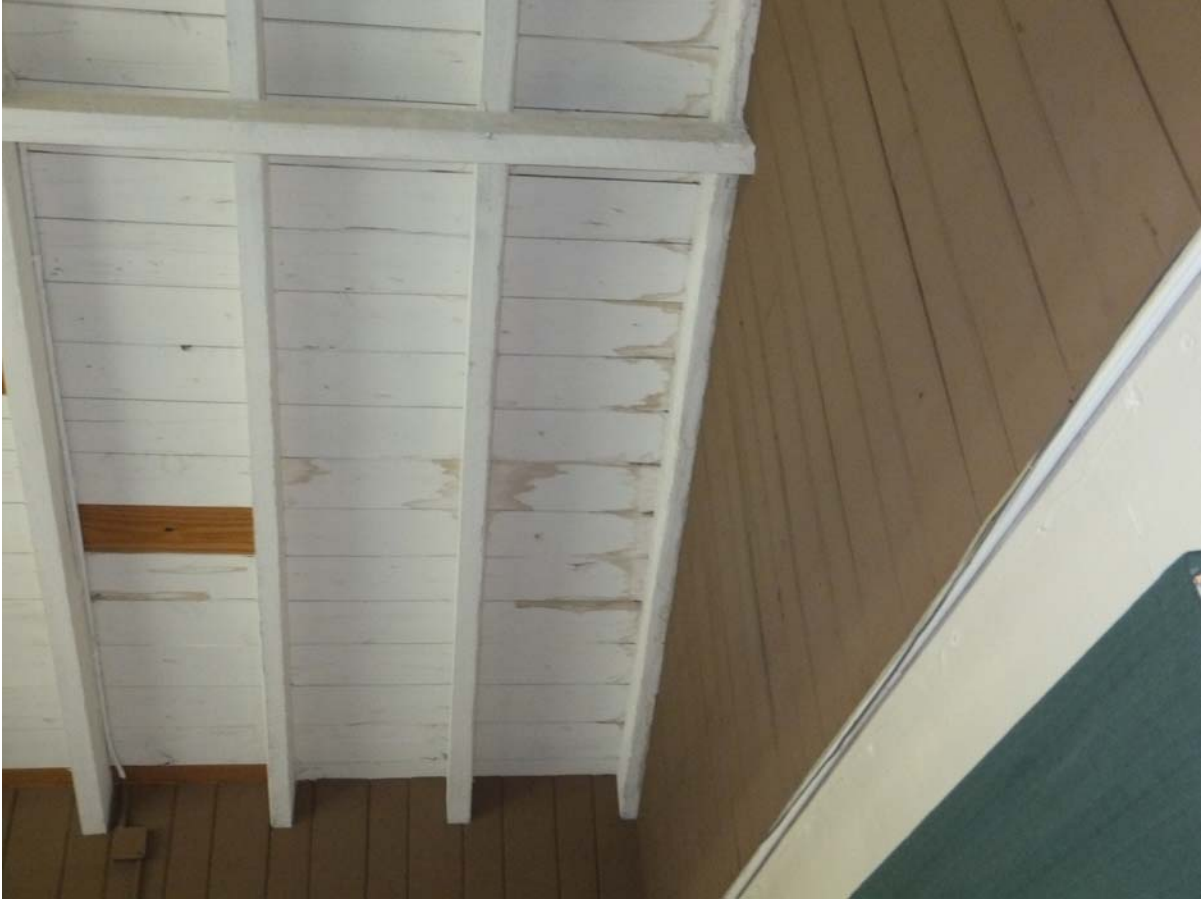
- There is evidence of water intrusion and water staining on the plank ceiling of the Sylvia Martin Building.
- A licensed Professional Engineer should further assess the condition of the roofing system for damage, water intrusion, and sufficiency.

Location	WD	FG	EM	Description	Photo #
Planning Office	√			Water staining and water damage to plank ceiling.	8

1. Submit all pre-approval items (Health and Safety Plan, Environmental Protection Plan, Work Plan, MSDS sheets for any chemicals used).
2. Obtain all necessary permits from local unit of government.
3. Remove and replace the entire roof if more than 25% of the roof is damaged, pursuant to the *Florida Building Code, 2007, Chapter 6, (1)(1)* “Not more than 25% of the total roof area or roof section of any existing building or structure shall be repaired, replaced or recovered in any 12 month period unless the entire roofing system or roof section conforms to the requirement of this code.”

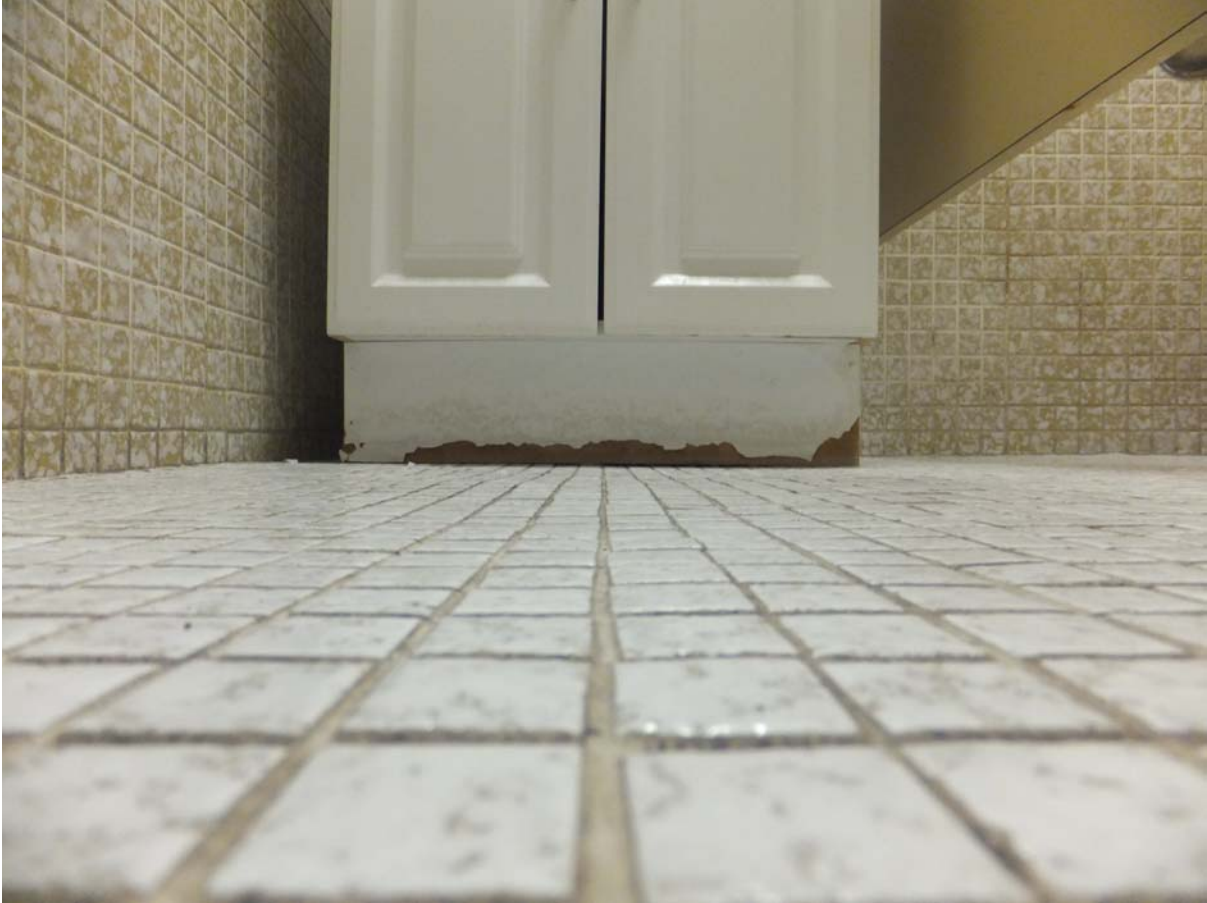
- The Vanity in the Women's restroom is water damaged, water stained, delaminated and separating. This Vanity should be removed and disposed of.

Location	WD	FG	EM	Description	Photo #
Planning Office	√			Water staining and water damage to Vanity in Women's Restroom.	8
