Report of Findings

**Assessment for Fungi at a Municipal Building
6130 Sunset Drive
South Miami, Florida 33143
File Number: 11-11-0803-M**

The City of South Miami

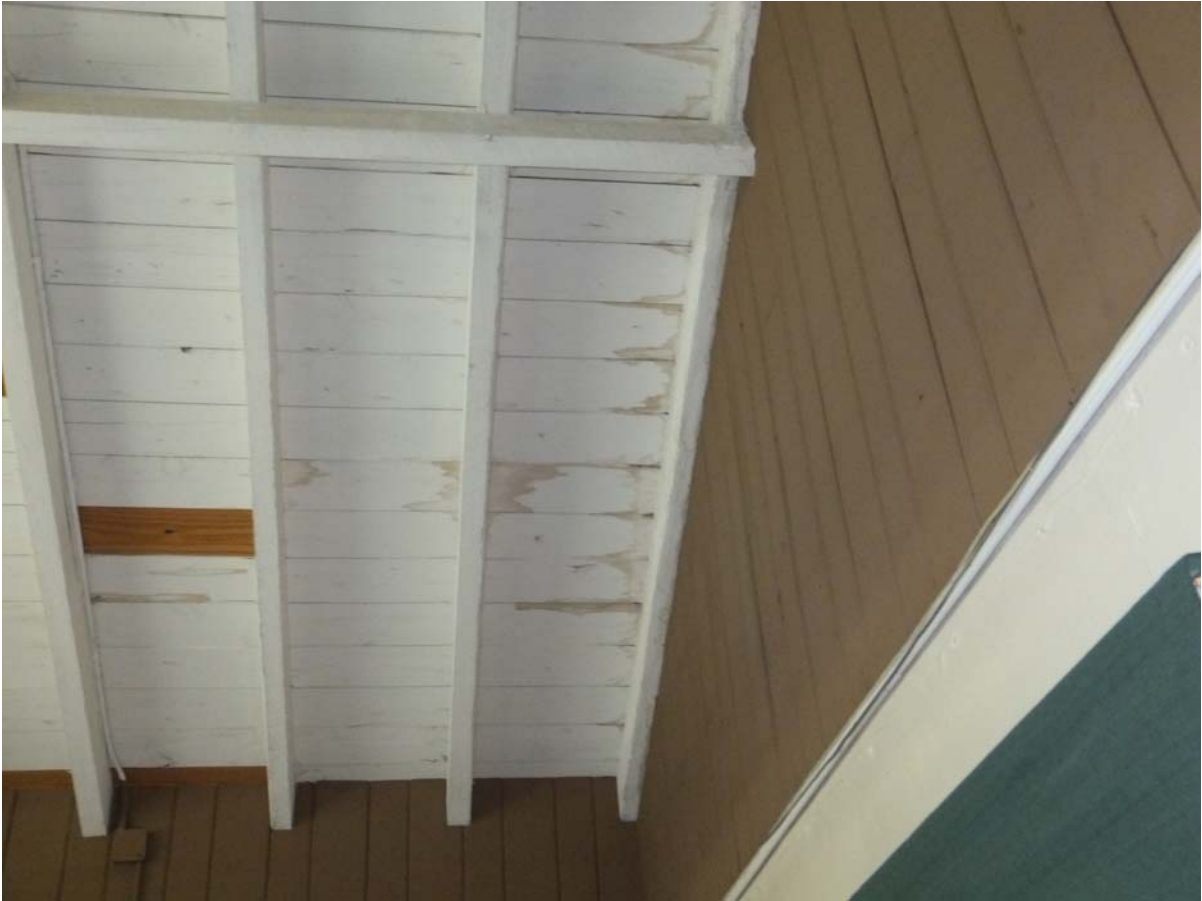
- There is evidence of water intrusion and water staining on the plank ceiling of the Sylvia Martin Building.
- A licensed Professional Engineer should further assess the condition of the roofing system for damage, water intrusion, and sufficiency.

Location	WD	FG	EM	Description	Photo #
Planning Office	√			Water staining and water damage to plank ceiling.	8

A licensed Professional Engineer should further assess the roofing system for sufficiency and damage.
