# HEI Systems

## Report of Findings

**Assessment for Fungi at a Municipal Building**  
**6130 Sunset Drive**  
**South Miami, Florida 33143**  
**File Number: 11-11-0803-M**

*The City of South Miami*

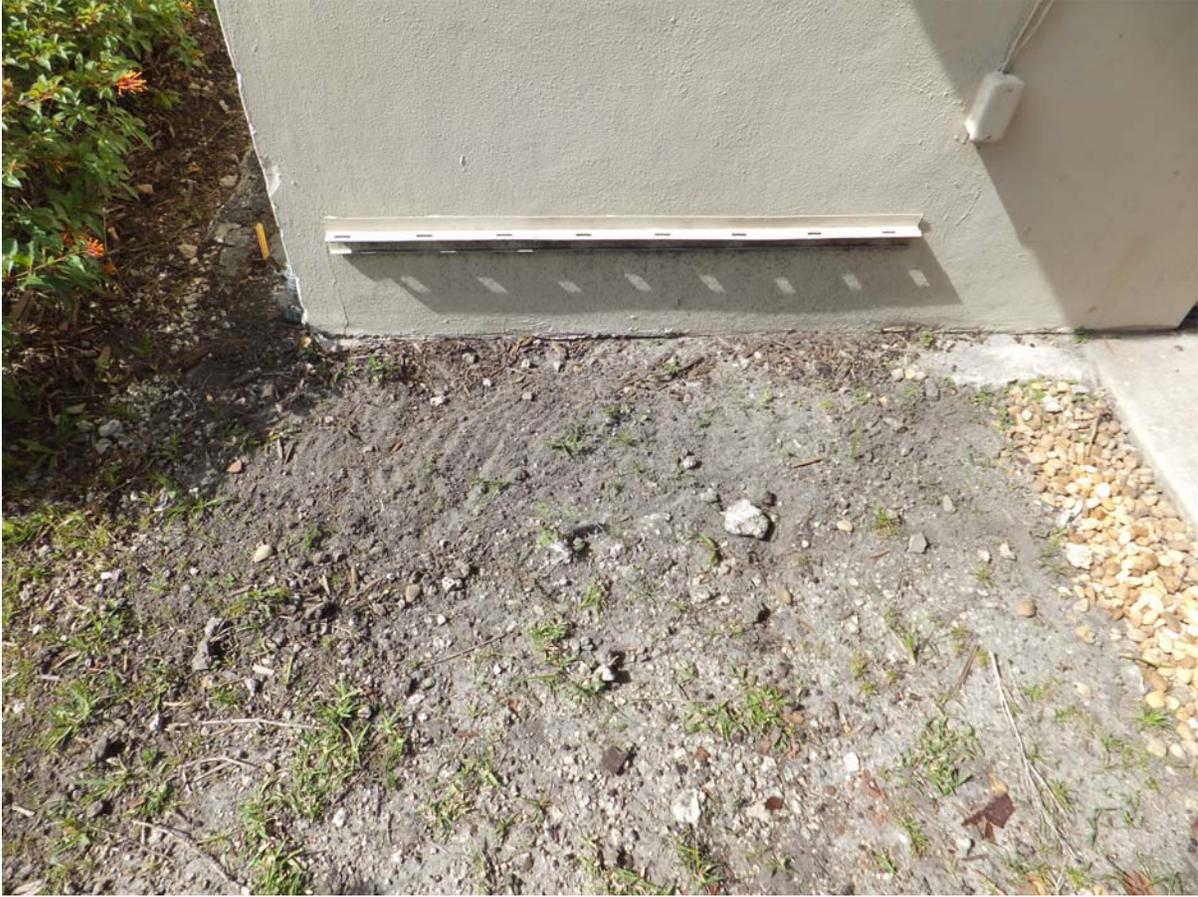
<b>Location</b>	<b>WD</b>	<b>FG</b>	<b>EM</b>	<b>Description</b>	<b>Photo #</b>
<b>Exterior</b>				Grading and landscaping issues allow for water intrusion.	<b>2</b>

- There is a visible exterior grading issue that should be further assessed by a licensed Professional Engineer. It appears that this grading issue facilitates the water intrusion into the building and should be corrected prior to interior restoration.

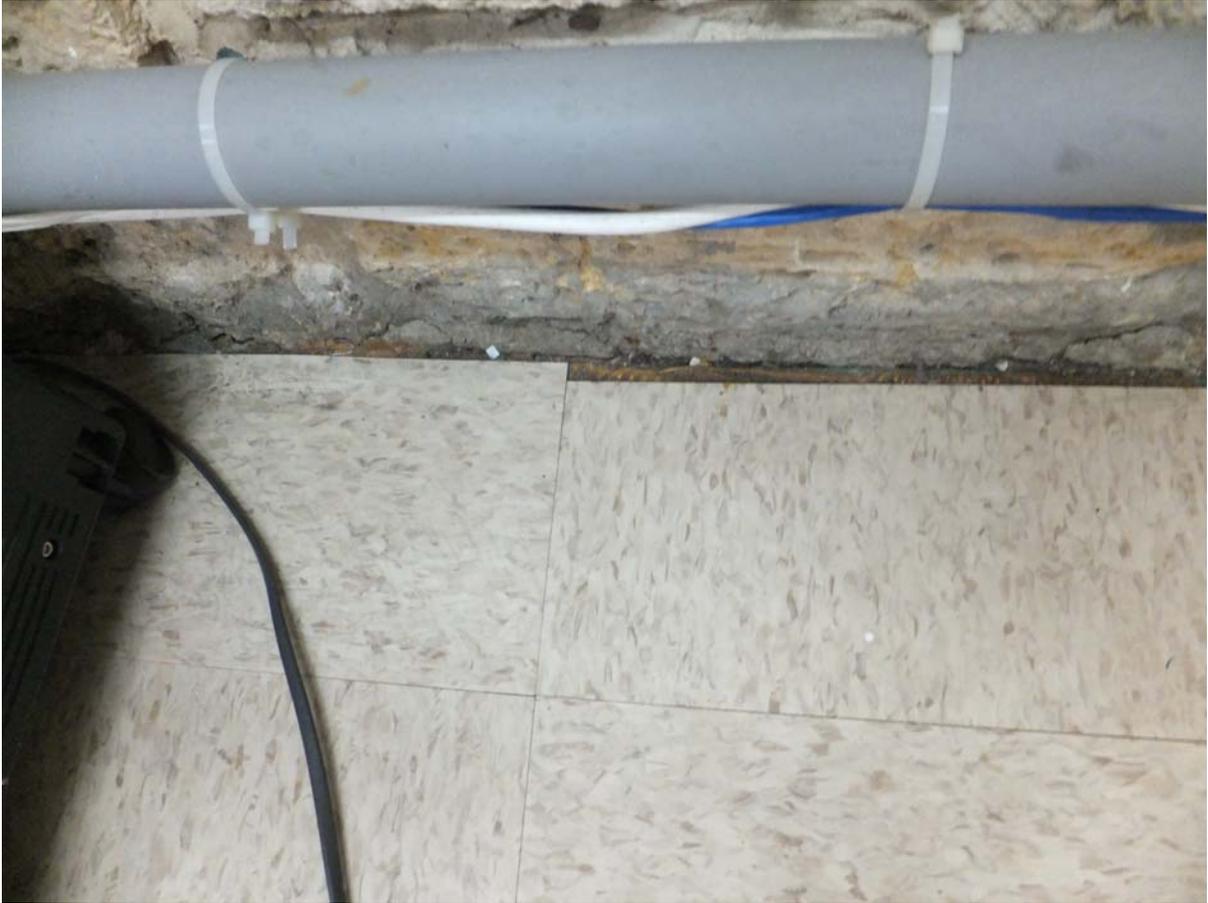
<b>Location</b>	<b>WD</b>	<b>FG</b>	<b>EM</b>	<b>Description</b>	<b>Photo #</b>
<b>Front Fingerprint Area</b>	√		√	Separation at wall edge allows water to intrude beneath floor tile and remain captured there.	<b>3</b>

- There is visible water damage and water stains along the wall bottoms in the Central Services Building. There is continued elevated moisture beneath the tile floor covering in the front fingerprint area of this building. There are openings at the edge of the tile floor covering and the adjoining wall that allows water intrusion beneath the tile floor covering. The tile floor covering should be removed under containment and disposed of. The slab should be abrasively cleaned to remove any remaining mastic and then re-sealed prior to the installation of any new floor covering.

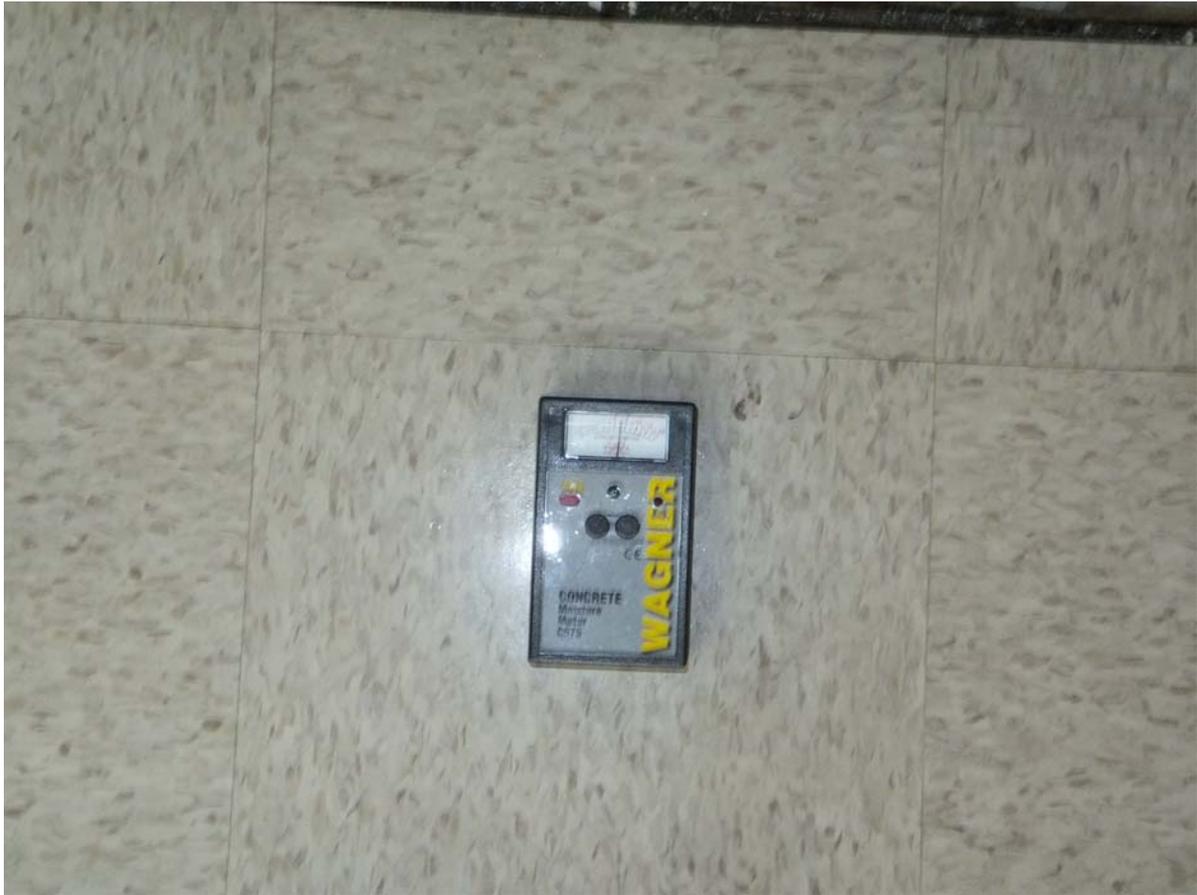
Location	WD	FG	EM	Description	Photo #
<b>Front Fingerprint Area</b>	√		√	Elevated moisture beneath floor tile when measured with a meter.	<b>4</b>

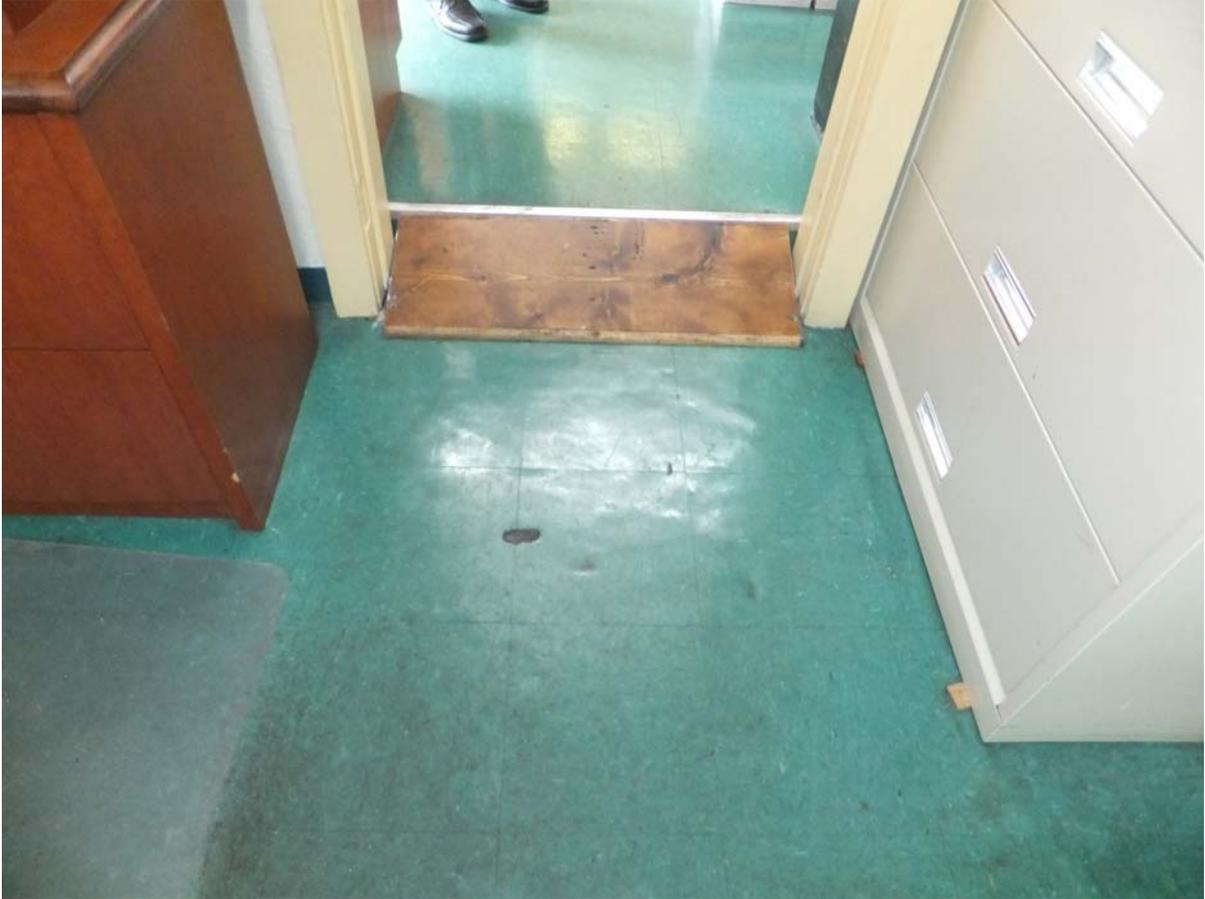
<b>Location</b>	<b>WD</b>	<b>FG</b>	<b>EM</b>	<b>Description</b>	<b>Photo #</b>
<b>Middle Room</b>	√		√	Elevated moisture in Middle Copy area does not extend into back room that is elevated.	<b>5</b>

- There is elevated moisture beneath the green tile floor covering in the Middle Room with the copy equipment. The elevated moisture ceases and is not present beneath the floor covering in the back office that is elevated by a step up. There is a distinct possibility that the green tile and mastic used beneath it contain asbestos. As such, this tile should be removed under the proper containment under negative air pressure, with appropriate HEPA filtration in place within the containment and disposed of in a legal manner pursuant to the statutes regulating asbestos. The slab should be abrasively cleaned to remove any remaining mastic and then re-sealed prior to the installation of any new floor covering.

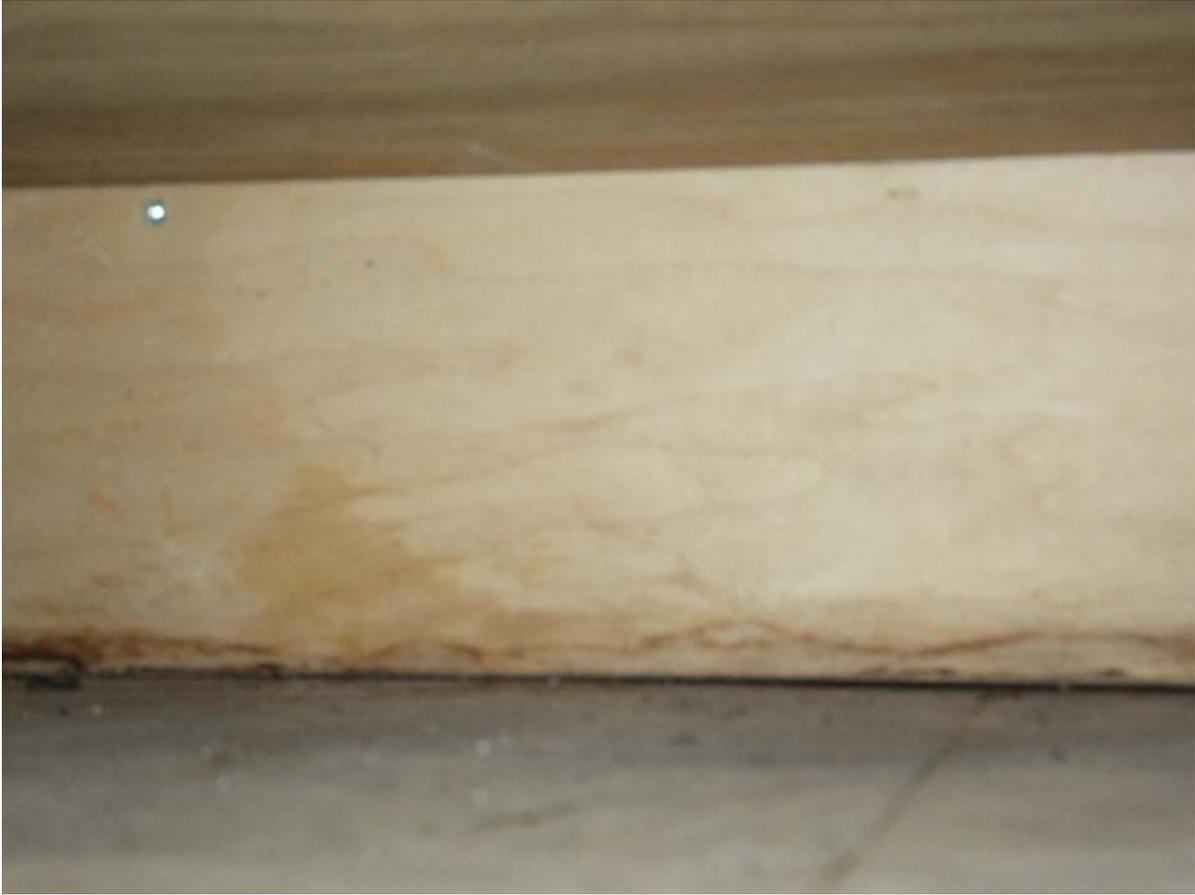
<b>Location</b>	<b>WD</b>	<b>FG</b>	<b>EM</b>	<b>Description</b>	<b>Photo #</b>
<b>Front Fingerprint Area</b>	√			Visible water damage and water staining to cabinet bottoms.	<b>6</b>

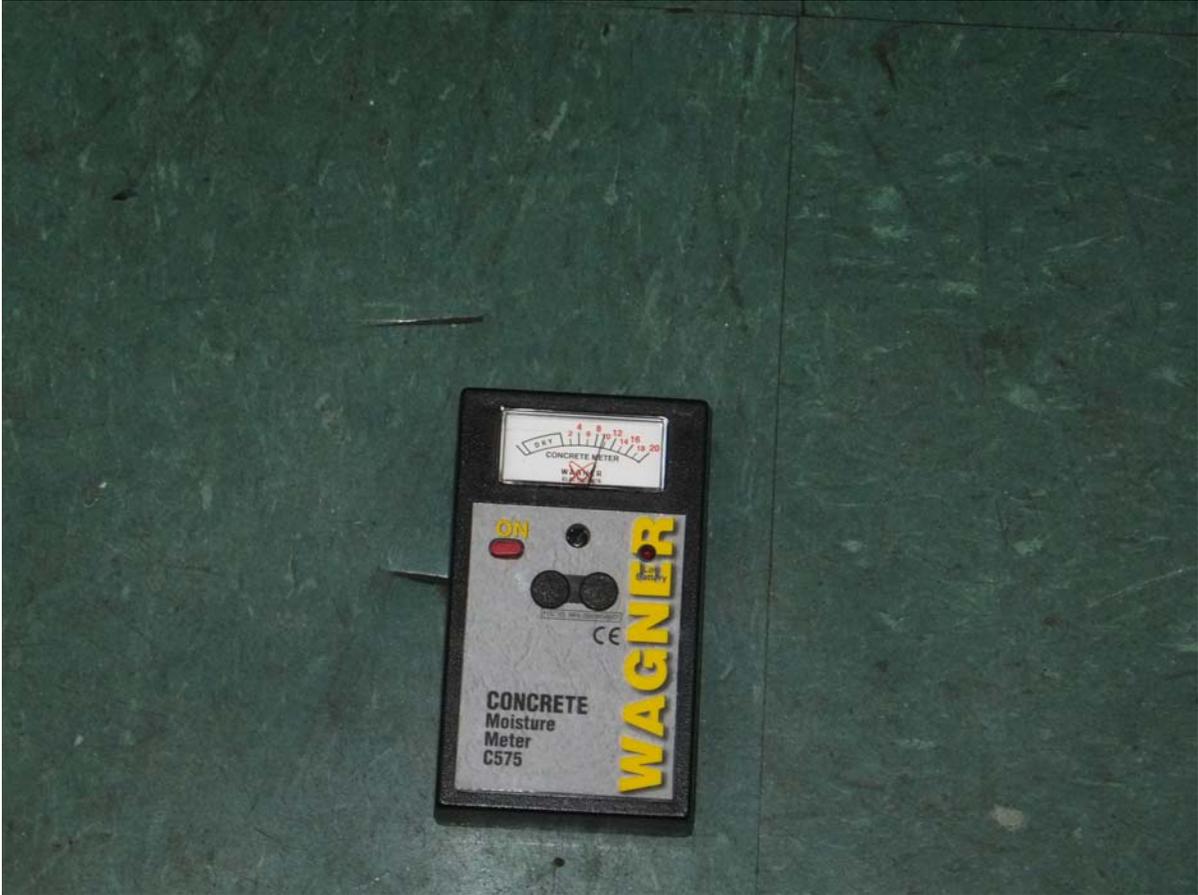
Location	WD	FG	EM	Description	Photo #
<b>Middle Copy Room</b>	√		√	Elevated moisture beneath tile floor covering.	7

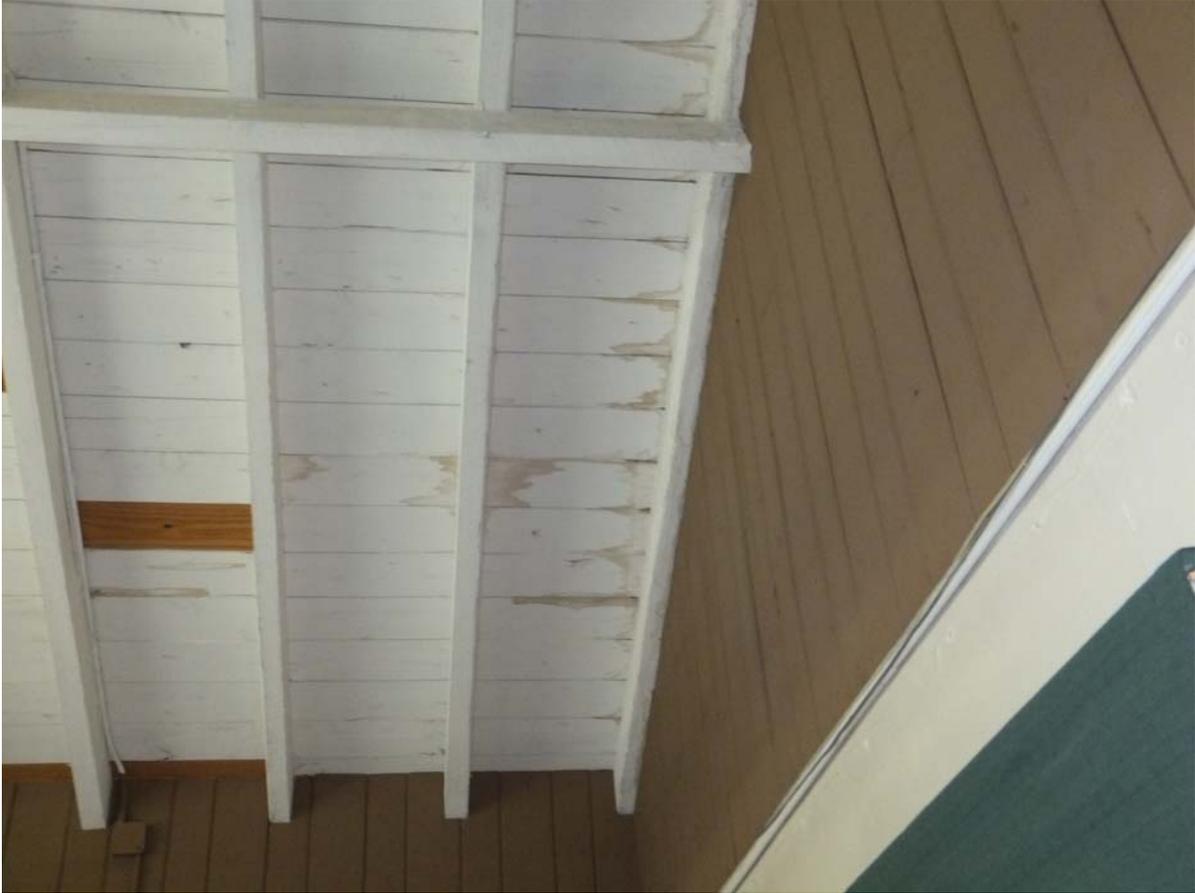
- There is evidence of water intrusion and water staining on the plank ceiling of the Sylvia Martin Building.
- A licensed Professional Engineer should further assess the condition of the roofing system for damage, water intrusion, and sufficiency.

<b>Location</b>	<b>WD</b>	<b>FG</b>	<b>EM</b>	<b>Description</b>	<b>Photo #</b>
<b>Planning Office</b>	√			Water staining and water damage to plank ceiling.	<b>8</b>

A licensed Professional Engineer should further assess the roofing system for sufficiency and damage.

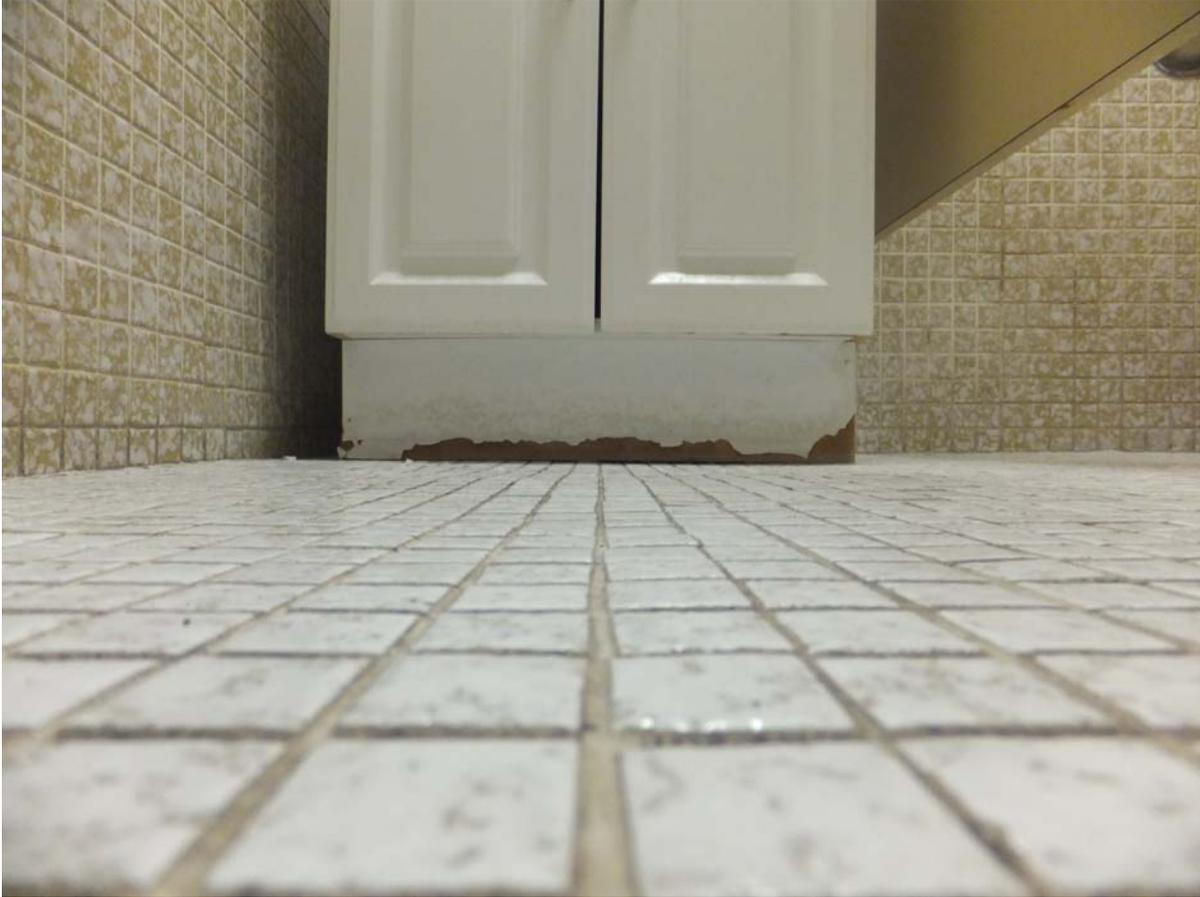
<b>Location</b>	<b>WD</b>	<b>FG</b>	<b>EM</b>	<b>Description</b>	<b>Photo #</b>
<b>Planning Office</b>	√			Water staining and water damage to Vanity in Women's Restroom.	<b>8</b>

- The Vanity in the Women's restroom is water damaged, water stained, delaminated and separating. This Vanity should be removed and disposed of.
