HEI Systems

Report of Findings

Assessment for Fungi at a Municipal Building
6130 Sunset Drive
South Miami, Florida 33143
File Number: 11-11-0803-M

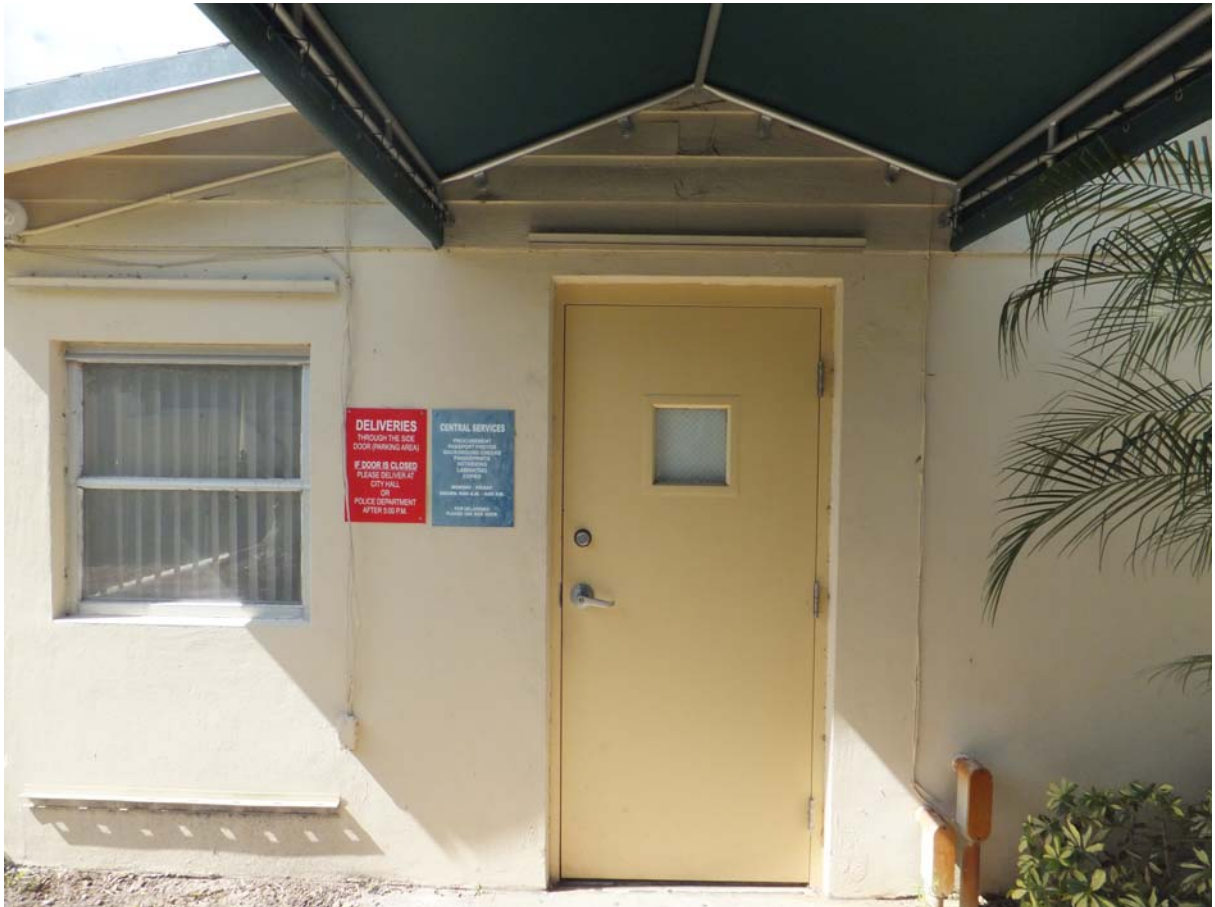
Location	WD	FG	EM	Description	Photo #
Front of Building				Photograph of the front of the building on the day of the assessment.	1
