Report of Findings

**Assessment for Fungi at a Municipal Building
6130 Sunset Drive
South Miami, Florida 33143
File Number: 11-11-0803-M**

The City of South Miami

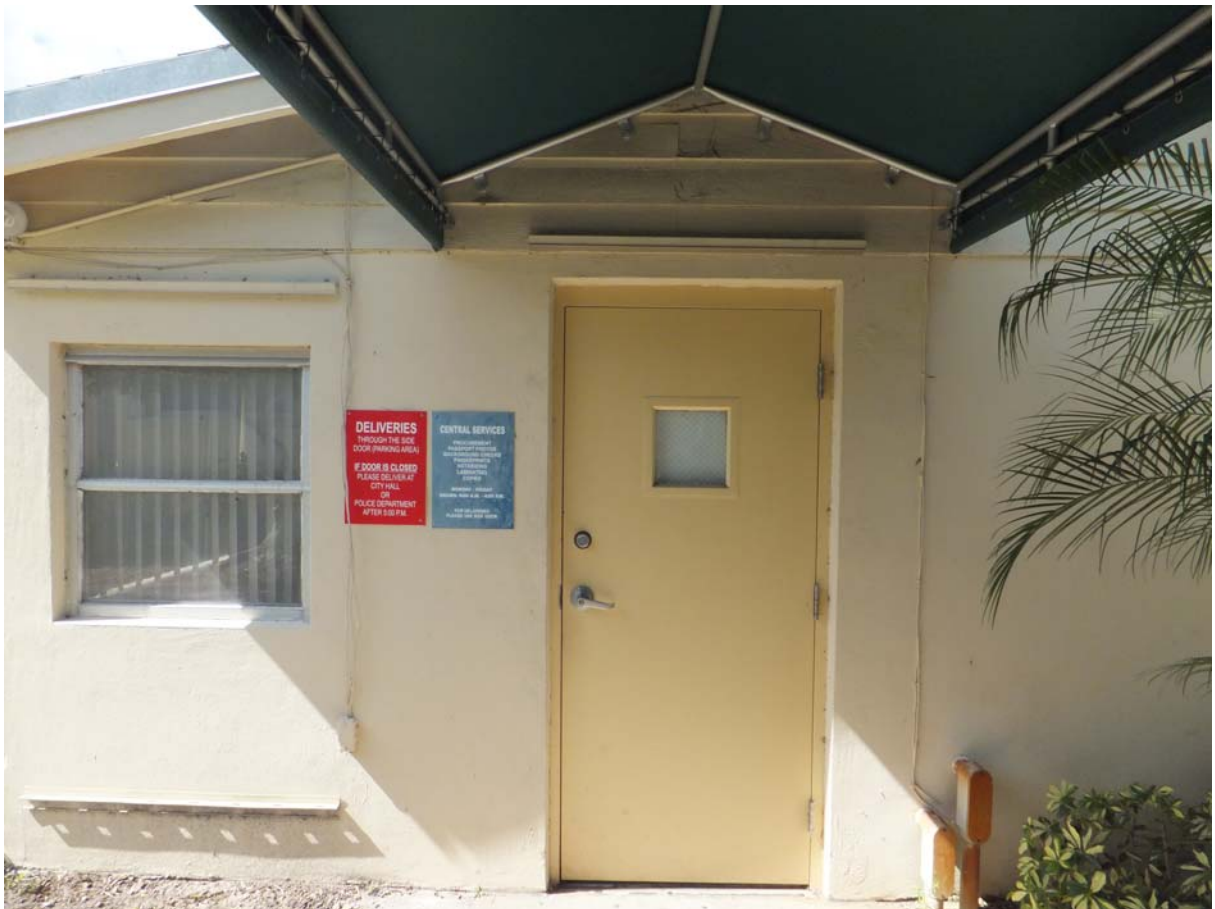
Location	WD	FG	EM	Description	Photo #
Front of Building				Photograph of the front of the building on the day of the assessment.	1
