# HEI Systems

## Report of Findings

**Assessment for Fungi at a Municipal Building**  
**6130 Sunset Drive**  
**South Miami, Florida 33143**  
**File Number: 11-11-0803-M**

*The City of South Miami*

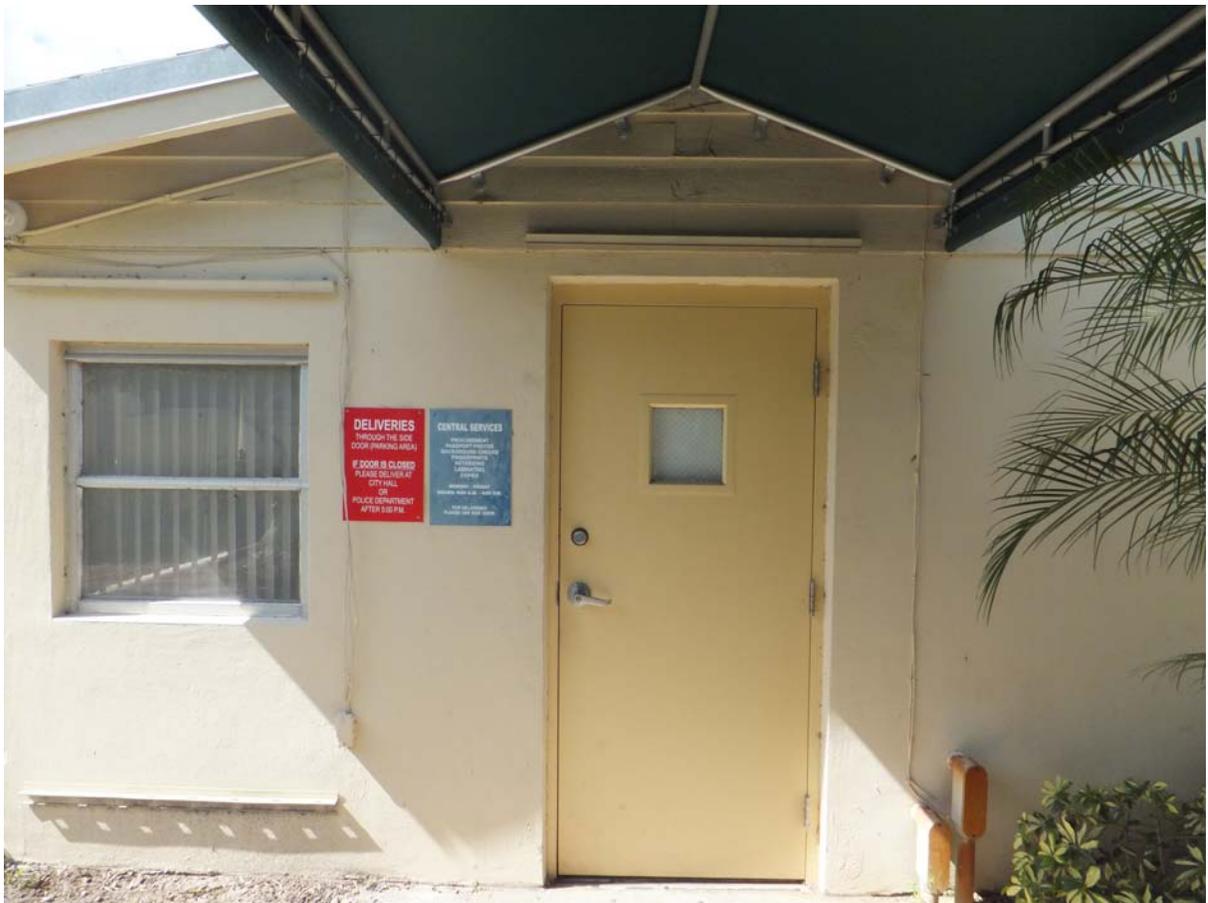
<b>Location</b>	<b>WD</b>	<b>FG</b>	<b>EM</b>	<b>Description</b>	<b>Photo #</b>
<b>Front of Building</b>				Photograph of the front of the building on the day of the assessment.	<b>1</b>
